HUGHES TOOL COMPANY · AIRCRAFT DIVISION
Culver City, California

Report 285-9-8 (62-8)

HOT CYCLE ROTOR SYSTEM
RESULTS OF COMPONENT TEST PROGRAM

FINAL REPORT

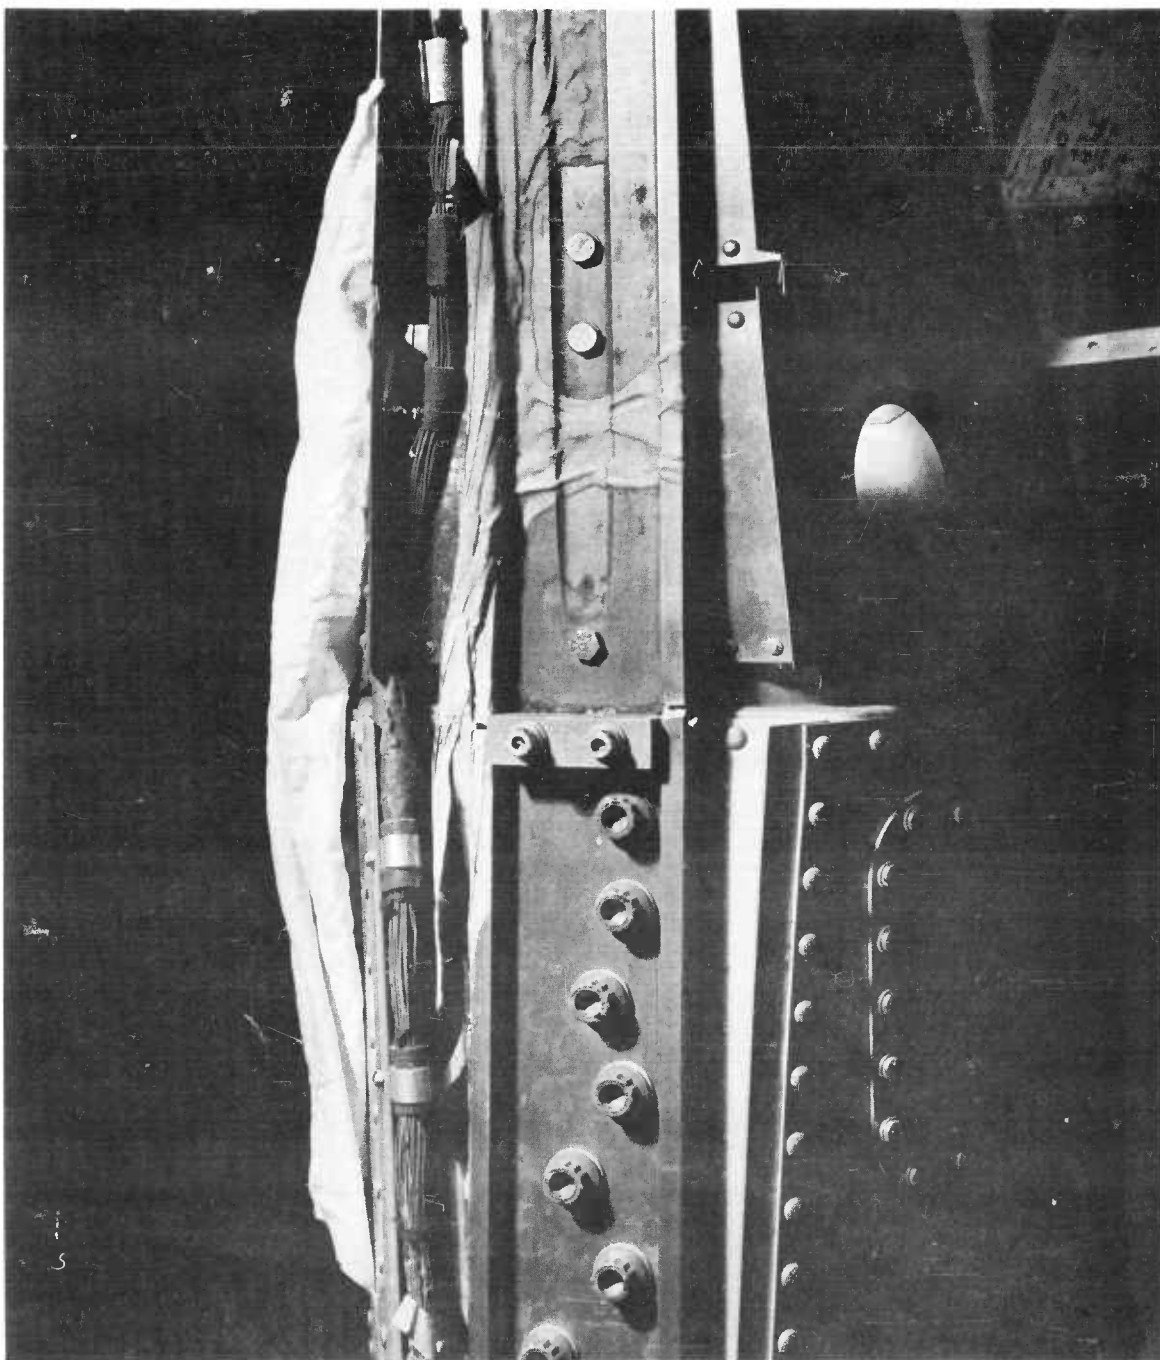
b. At 266,000 cycles of load simulating the Weighted Fatigue Condition, the aft spar of the fatigue blade failed. The rupture consisted of a vertical break at Station 73 through two 5/16 inch bolt holes in the spar webs (Figures 3-14 and 3-15), which are provided for bolts that react the loads induced by a slight change in direction of the spars. Inspection of the failure area revealed that the fatigue crack had started at the upper hole (Figures 3-16 and 3-17) and worked out through the upper flange. The remainder of the failed section had the appearance of a ductile failure. Laboratory examination; showed normal Alpha structure for the Ti 6Al-4V with no inclusions present. Burrs and galling were evident in the holes with minute cracks visible in the burrs at the edge of the hole. Figures 3-18, 3-19, 3-20 and 3-21. This condition was the result of a reaming operation on final assembly. Although it was intended that the ends of the holes through the spar web have rounded edges, the .005-.010 radius called out in Drawing No. 285-0170 was lost when it was found necessary to enlarge the holes during final assembly after the spars were partially attached to the blade structure. The burred and cracked condition discussed above escaped detection, particularly on the back side of the spar web where it bears against the blade segments and is not accessible to inspection except by removal of the spar.

Figure 3-14. Rear Spar Failure at Station 73.0

The failed rear spar was replaced with a spare whirl test blade spar. The outboard portion of the rear spar was strengthened with a titanium doubler. HTC-AD Drawings 285-0224, 285-0225 and 285-0226 show the rework of the outboard portion of the rear spar. The rework of the inboard portion of the rear spar is shown in HTC-AD Drawing 285-0223. Figures 3-22 and 3-23 show the inboard reworked area. The front spar was reinstalled with new bolts replacing the bolts that were sheared due to secondary failure.

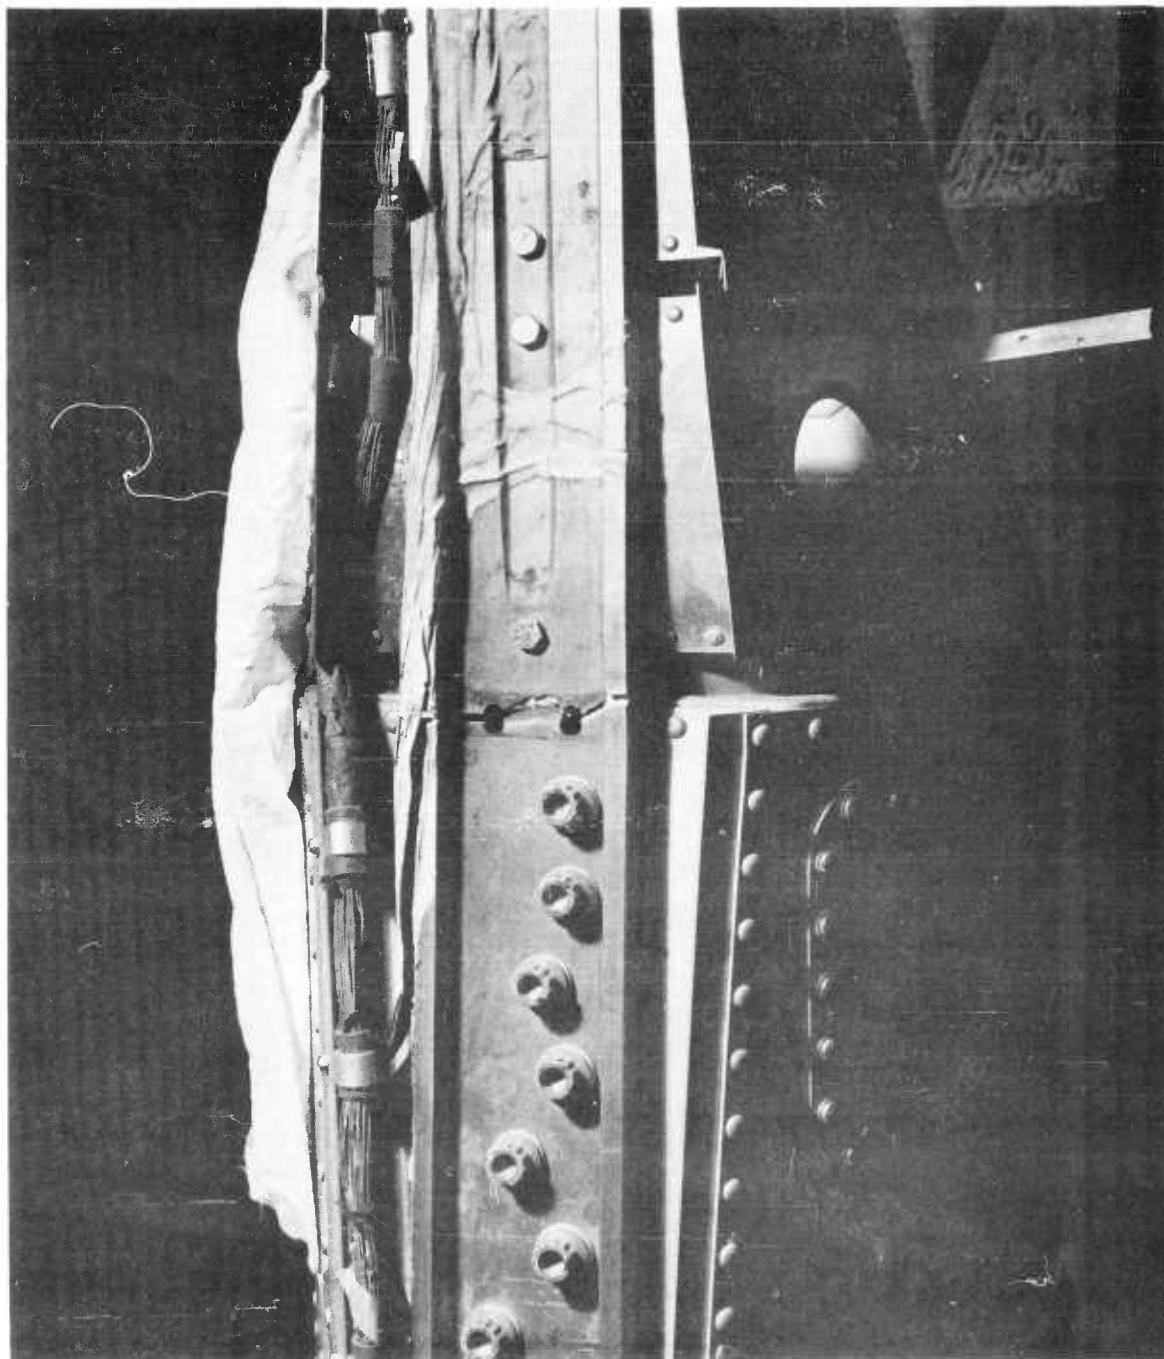
Figure 3-15. Rear Spar Failure at Station 73.0, Bolts Removed

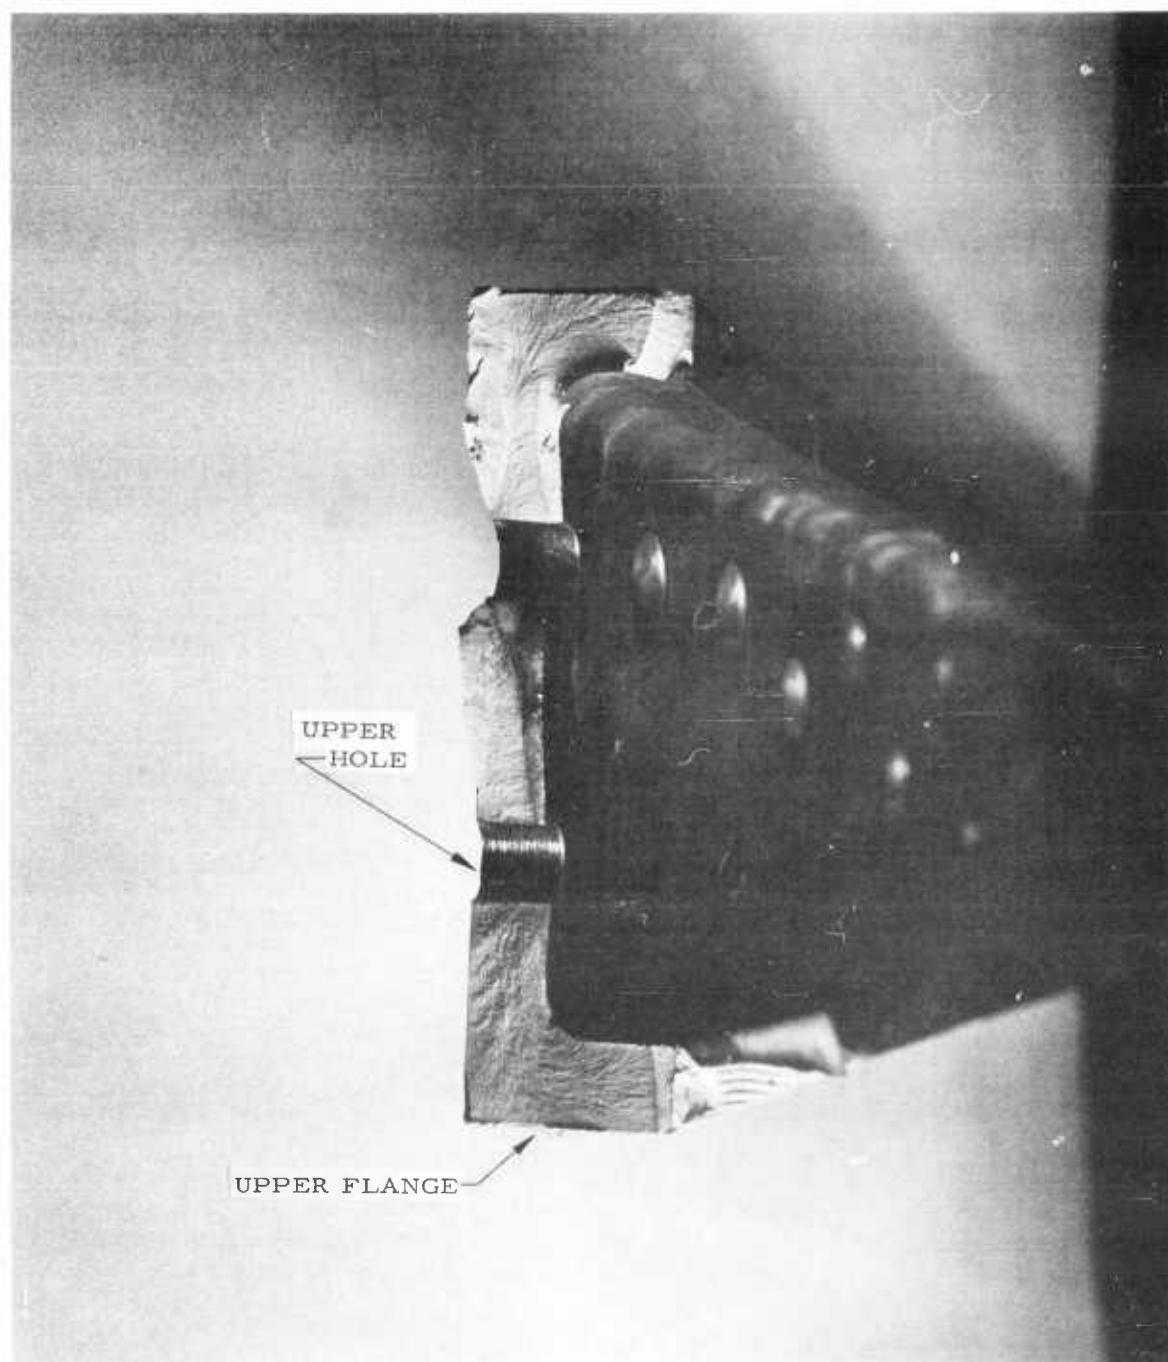
Figure 3-16. Rear Spar Fracture Area -- Inboard Portion

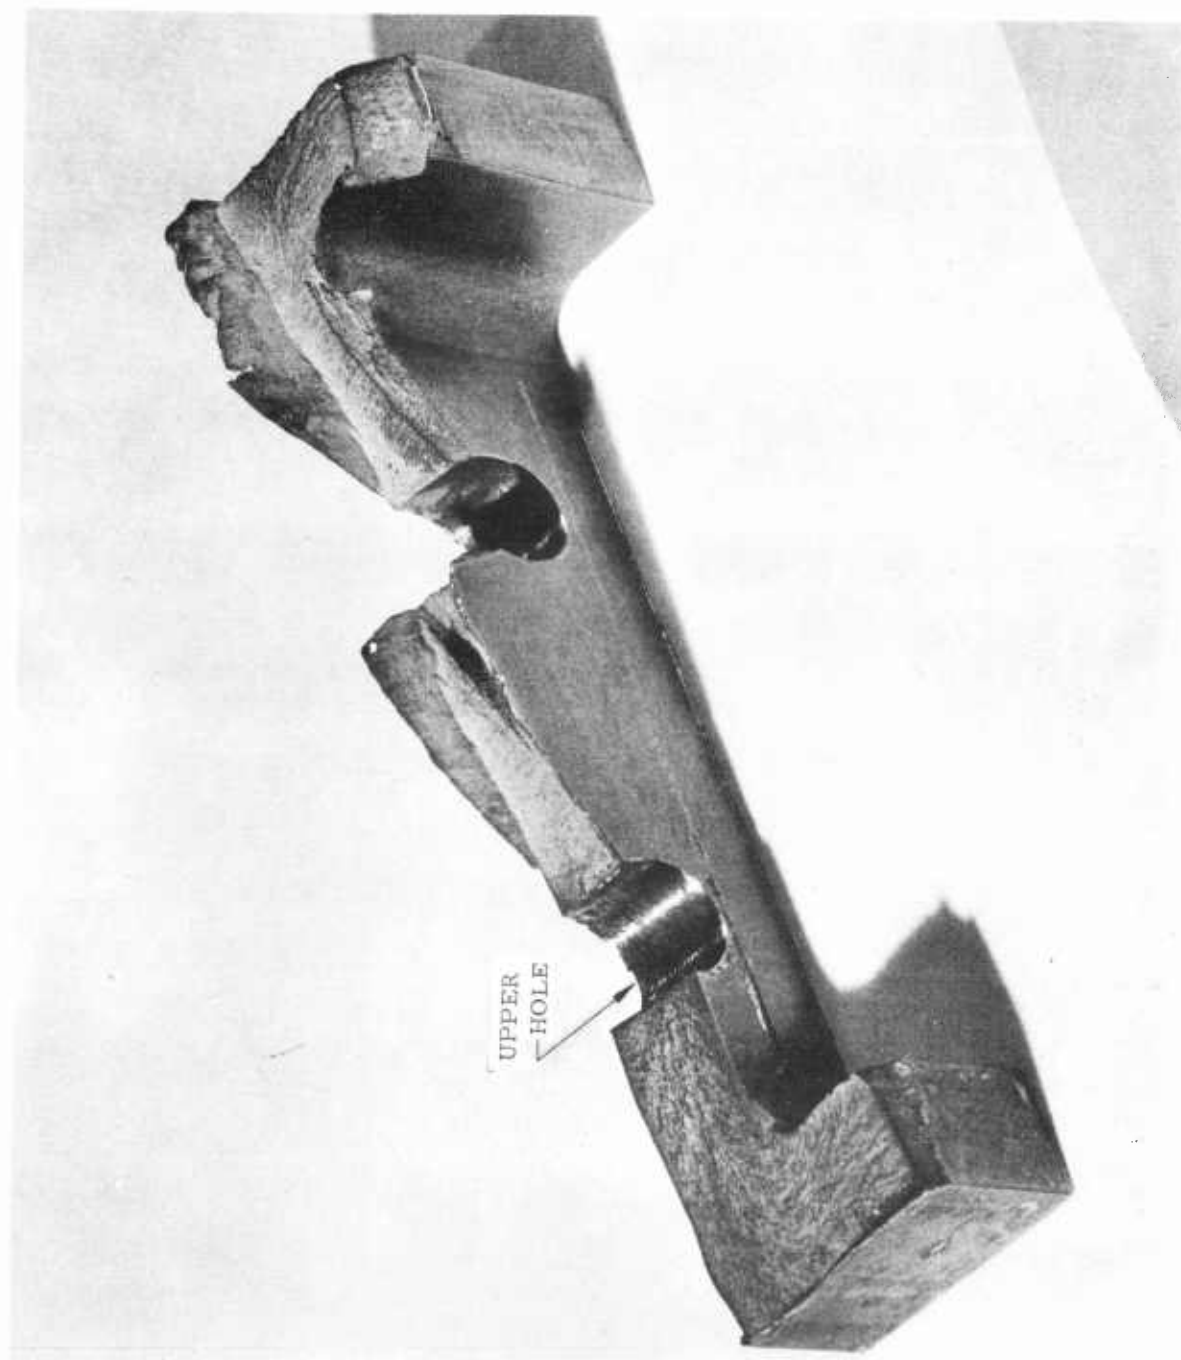
Figure 3-17. Rear Spar Fracture Area -- Inboard Portion

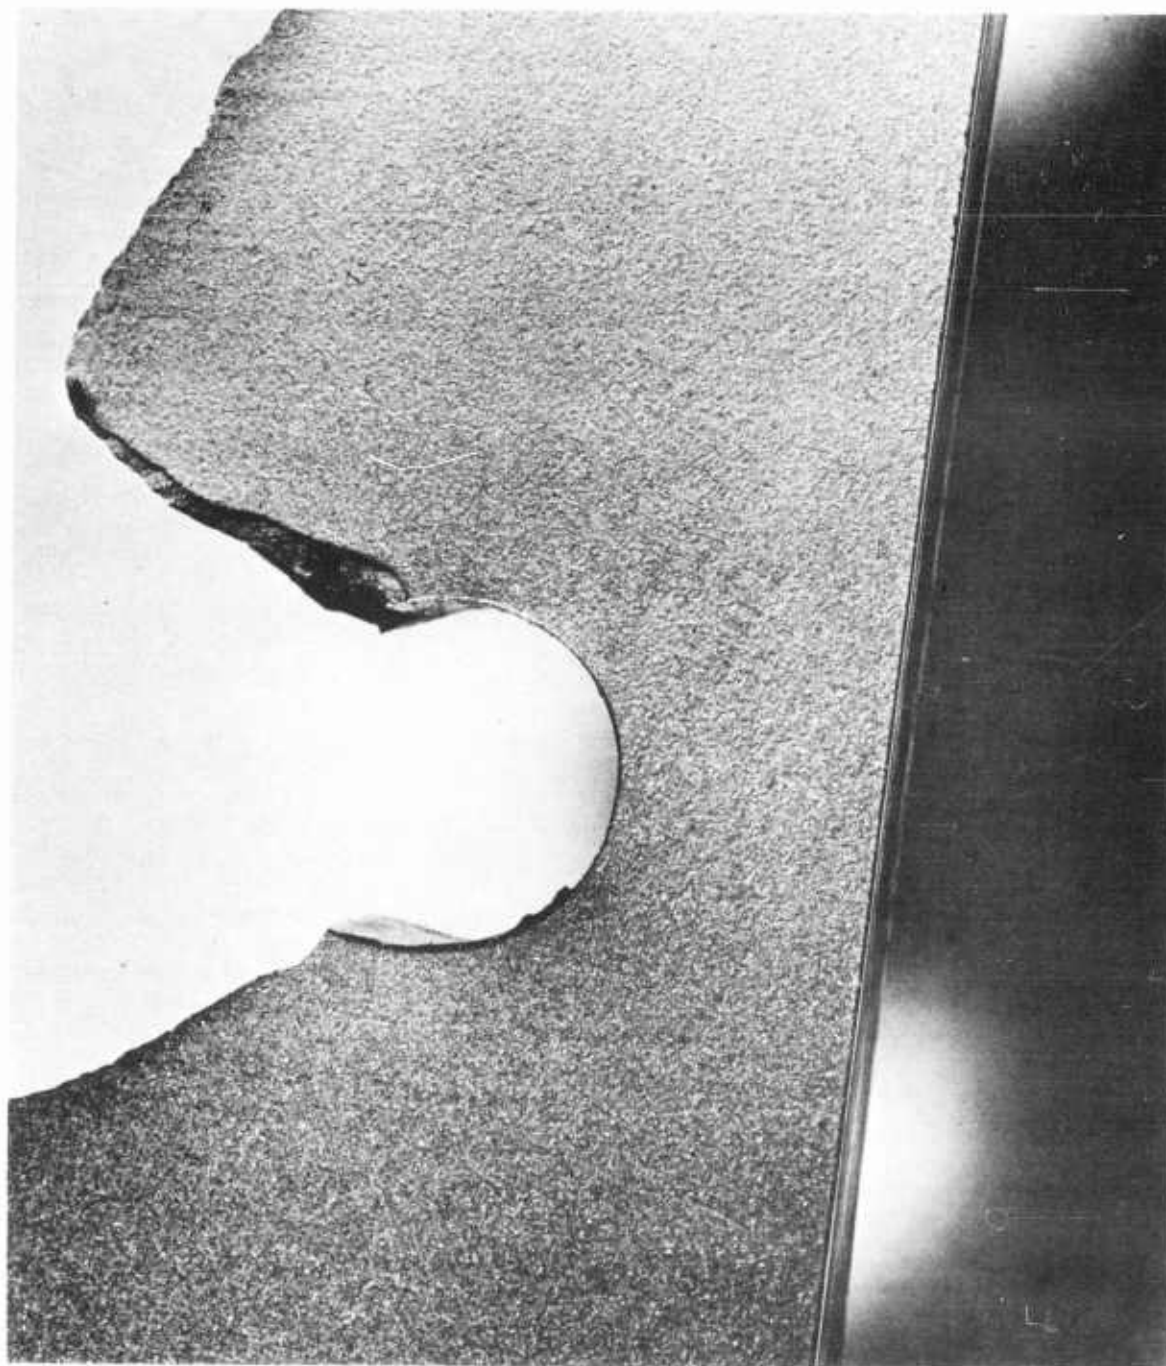
- (1) Burrs and galling present in holes.
- (2) Minute cracks visible in burrs.

Figure 3-18. Rear Spar Fracture Area -- Burrs on Edge of Hole

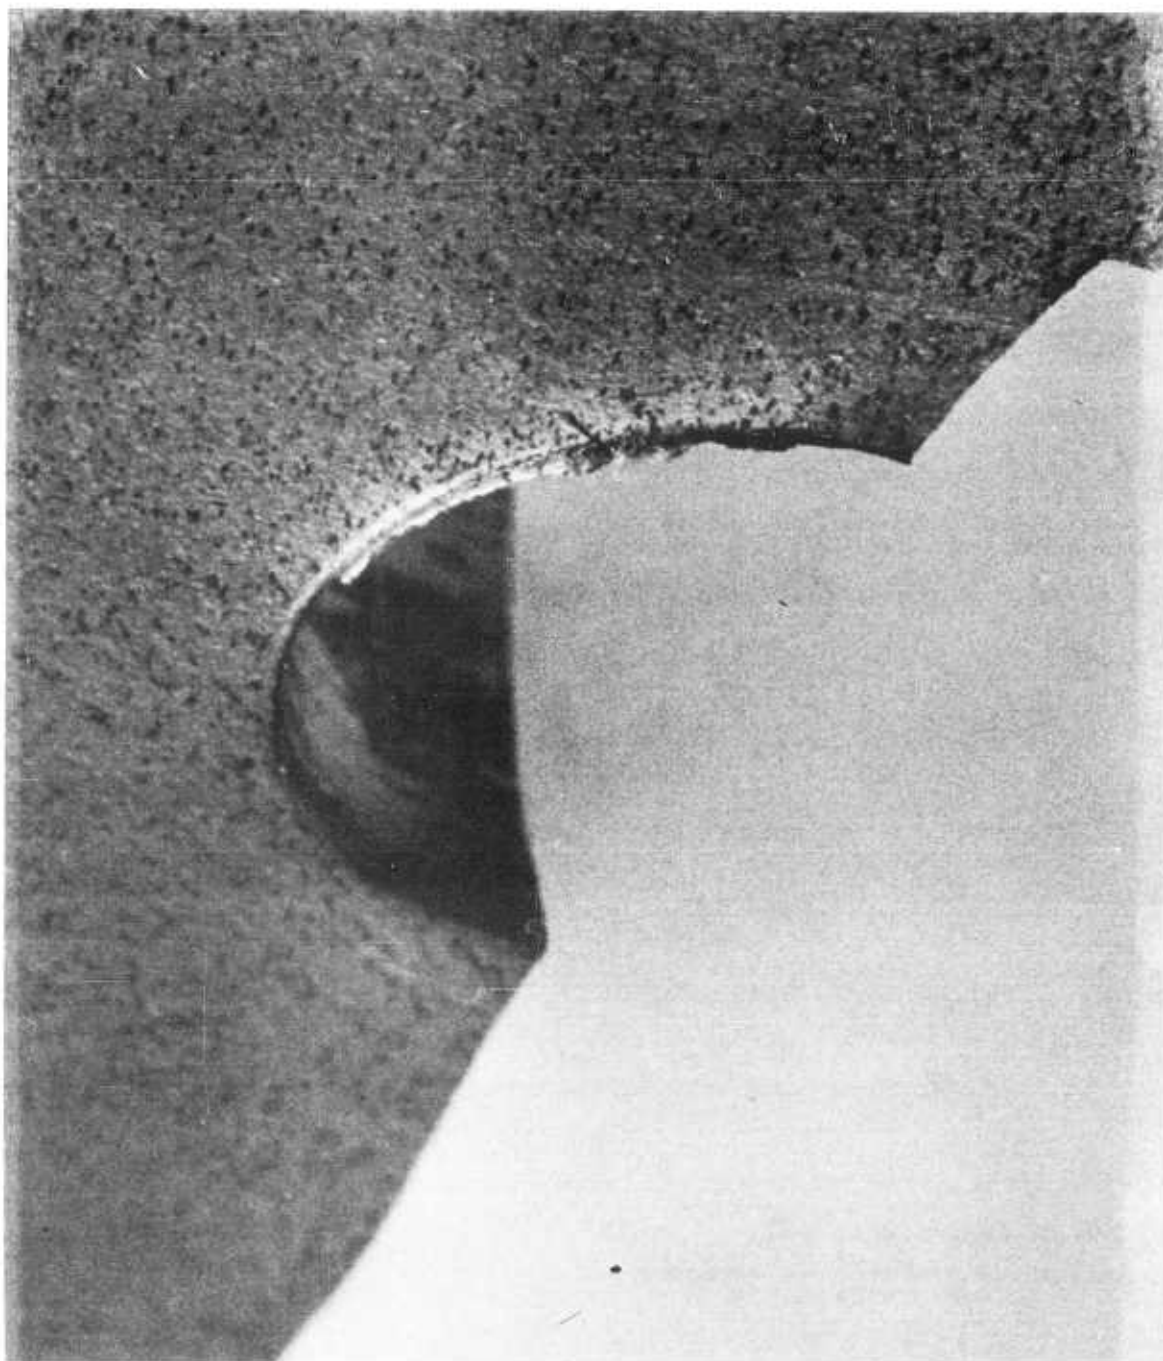
The results of the failed aft spar specimen fatigue tests are shown in Table 3-2. Due to the limited number of specimens tested and the difficulty in reproducing the type of burr as shown in Figure 3-19 conclusive evidence of a marked decrease in the fatigue life cannot be stated. The limited data shows only that a trend in the reduction of fatigue life due to a burr is indicated.

Figure 3-19. Rear Spar Fracture Area -- View of Crack in Burr

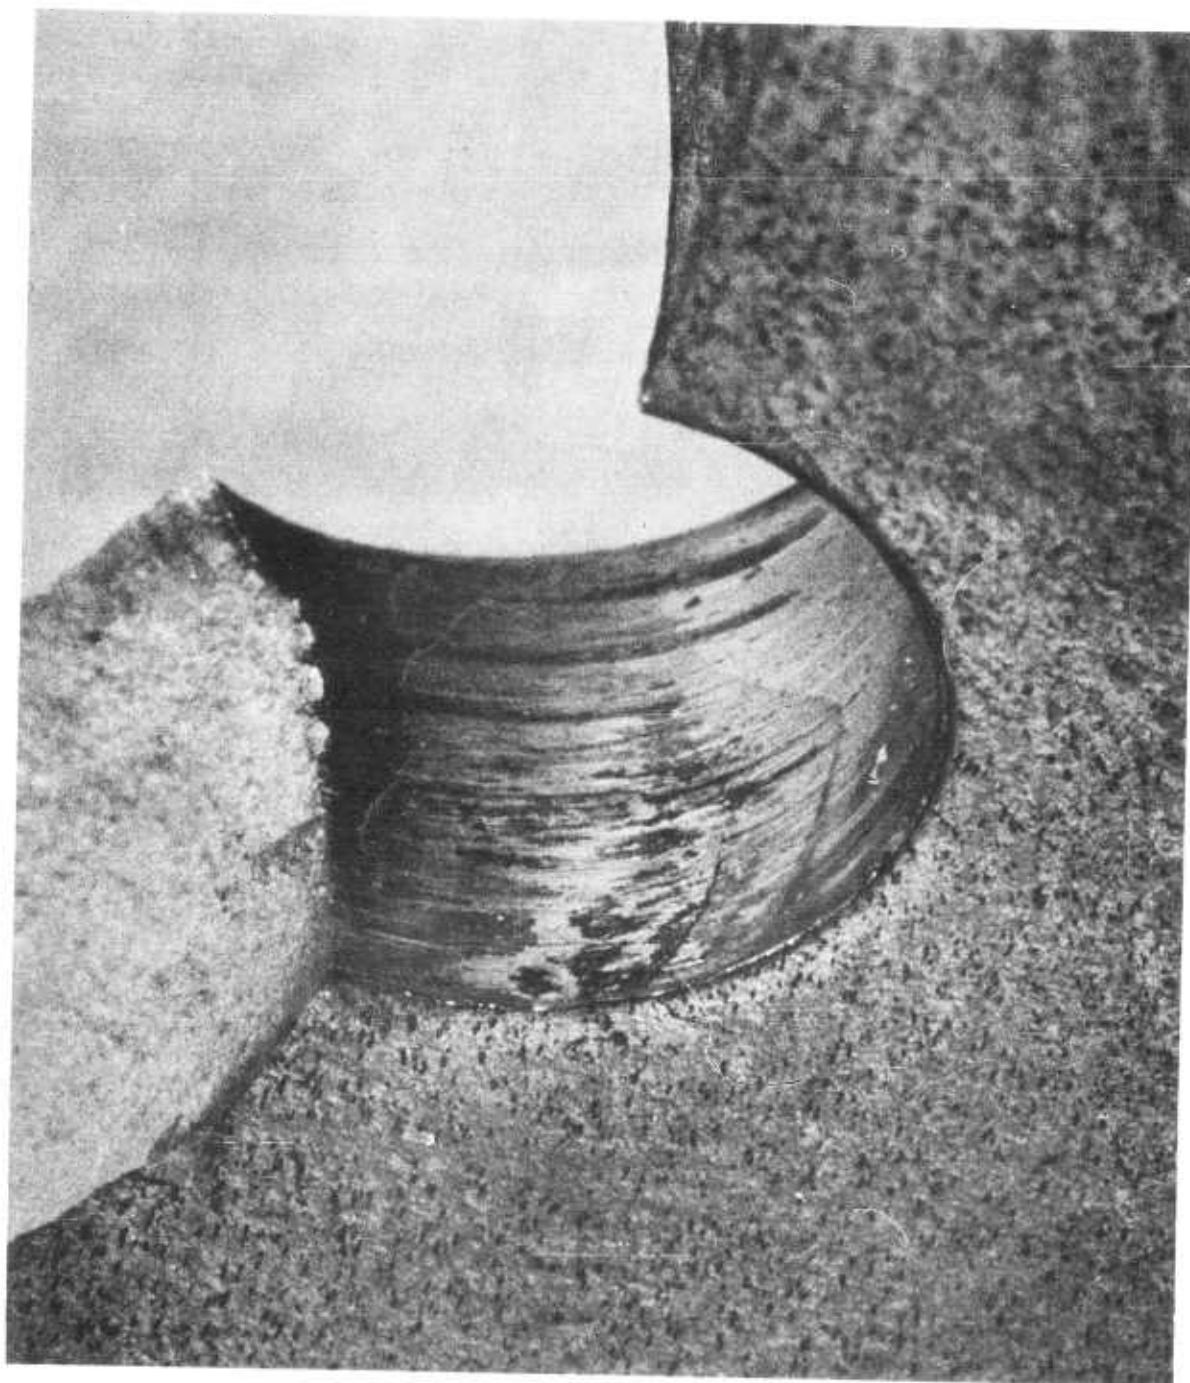
Figure 3-20. Rear Spar Fracture Area -- View of Crack in Burr

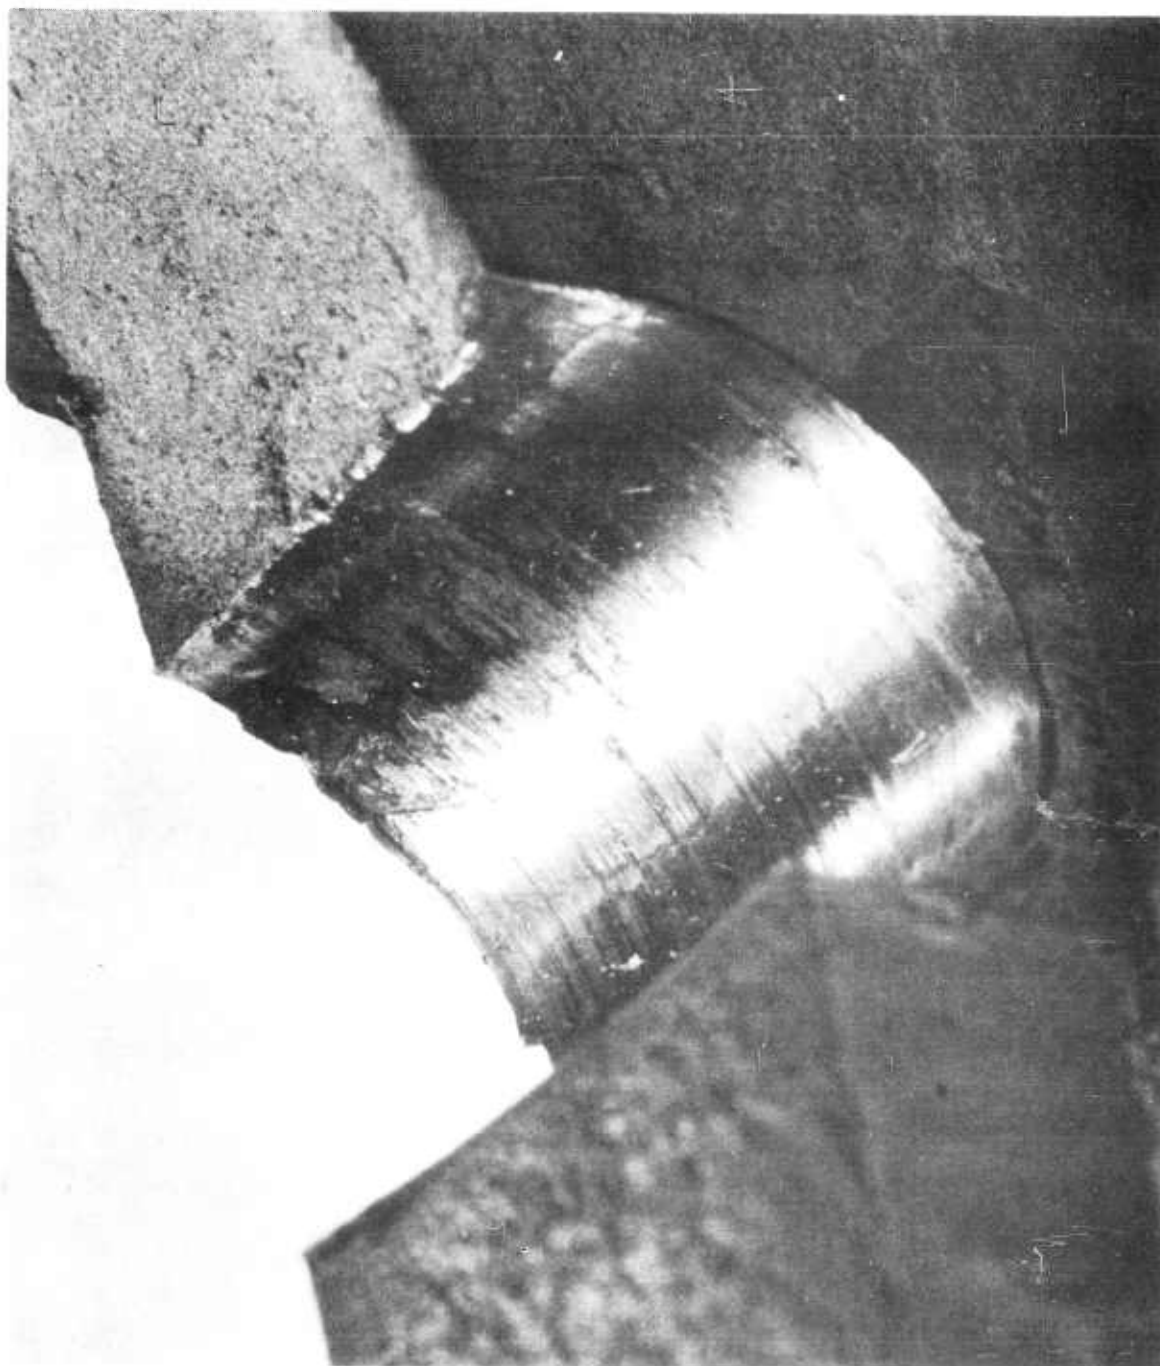
Figure 3-21. Rear Spar Fracture Area -- View of Crack in Burr

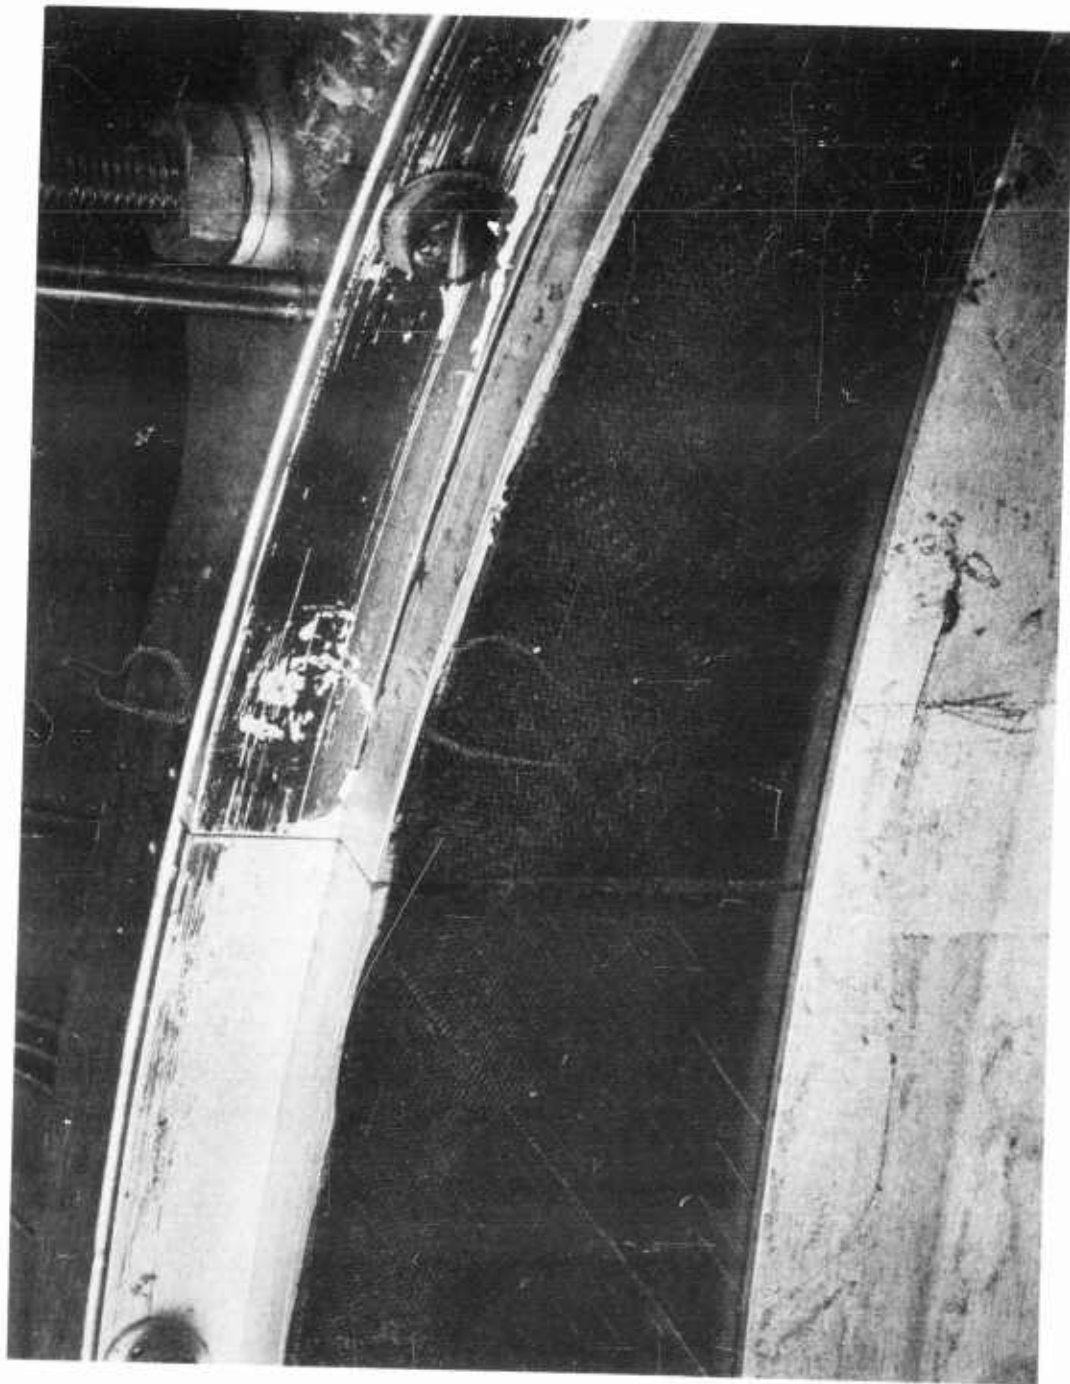
The spherical bearing and retainer was subject to 26.5 hours of cycling. Inspection of the bearing and Fabroid bonded retainer revealed that a small amount of flaking of teflon fibers had occurred. No indication of increased clearance or damage of any kind was noted. The bearing and retainer after test is shown in Figures 7-5, 7-6, 7-7 and 7-8.

Figure 7-5. Fabroid Bearing after 26.5 hrs. of Test (no apparent damage)
Lower Left in Fixture

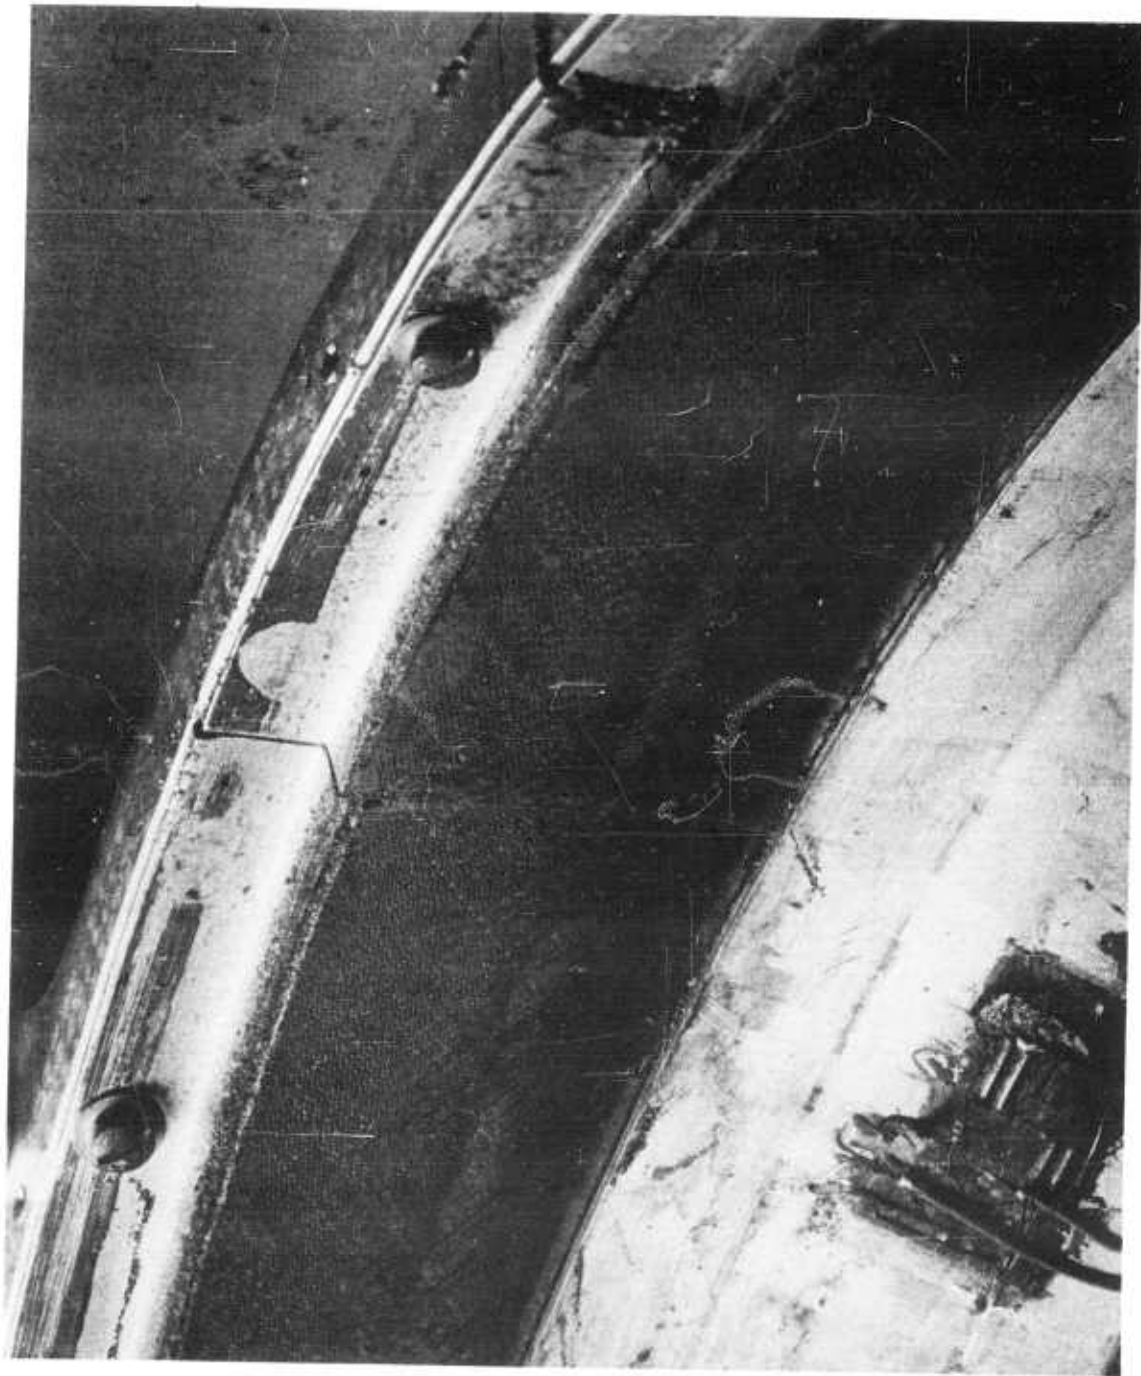
Figure 7-6. Fabroid Bearing after 26.5 hrs. of Test (no apparent damage)
Upper Left in Fixture

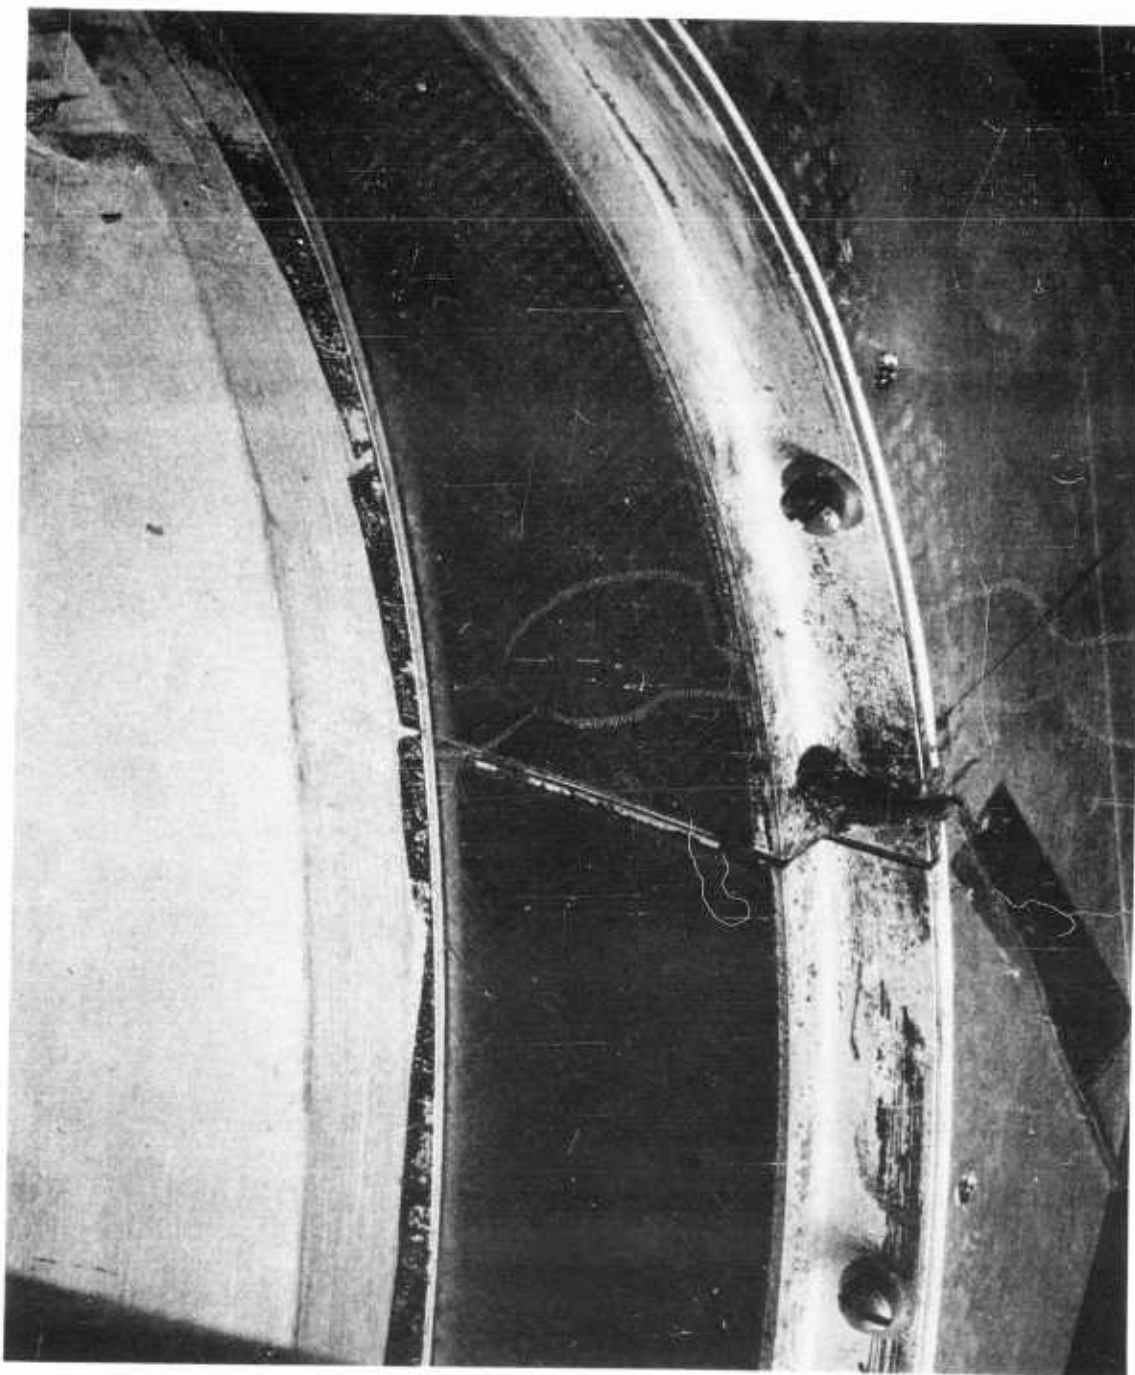
Figure 7-7. Fabroid Bearing after 26.5 hrs. of Test (no apparent damage)
Right Side in Fixture

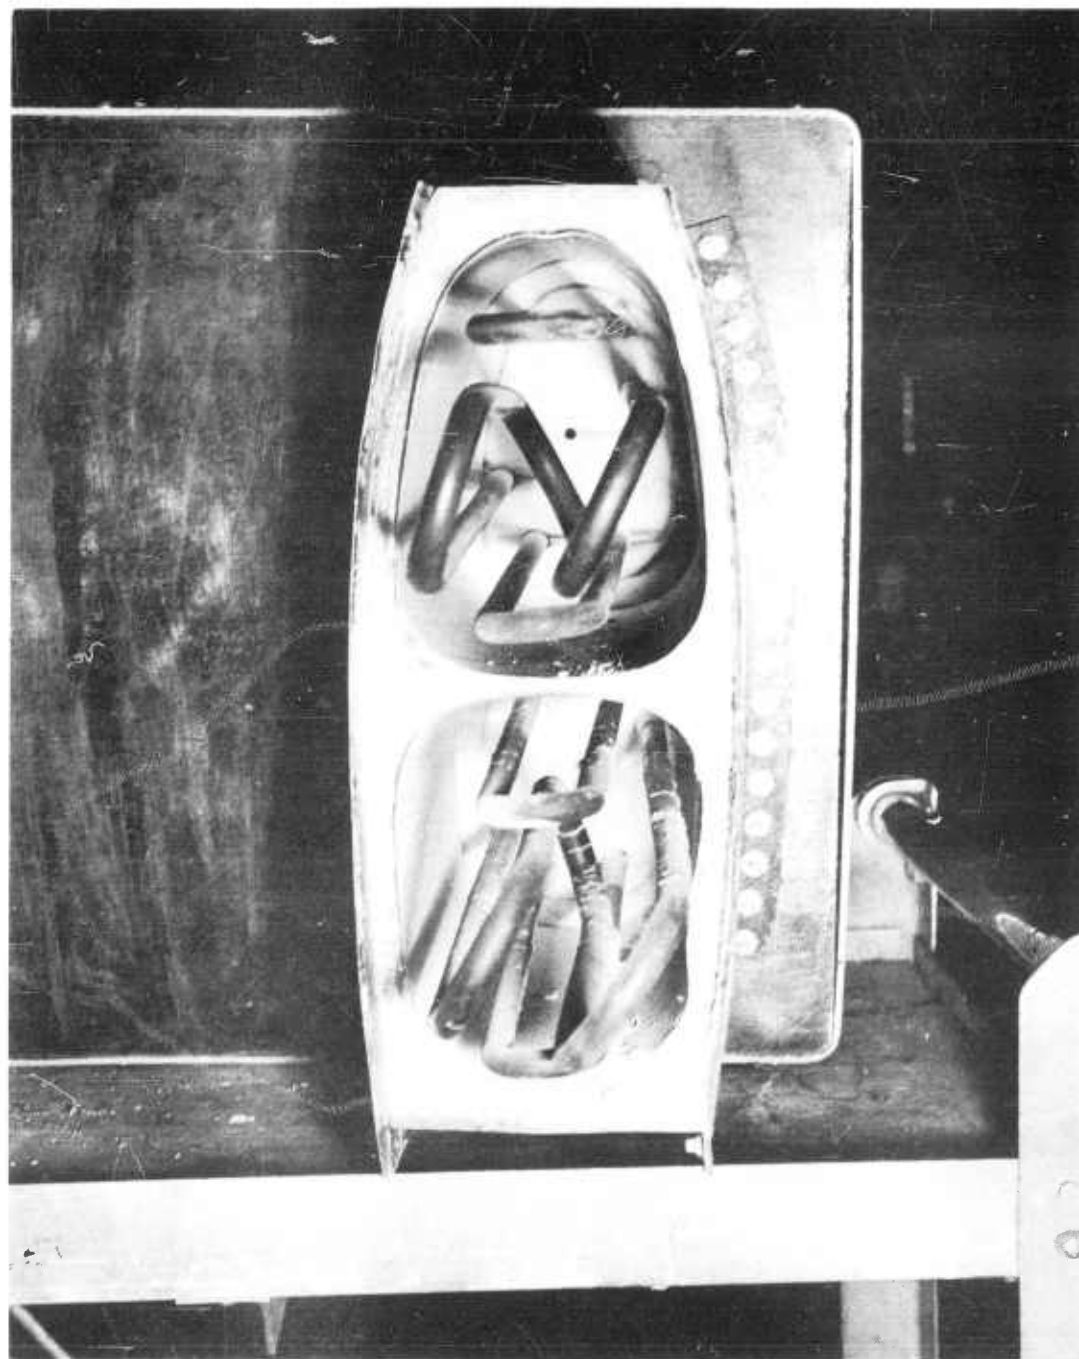
The temperature distribution in the specimen for each test phase is given in Figure 8-1. The condition of the sealant compound after test is shown in Figures 8-4, 8-5, 8-6, 8-7 and 8-8.

Figure 8-4. View of Flexural Coupling and Sealant

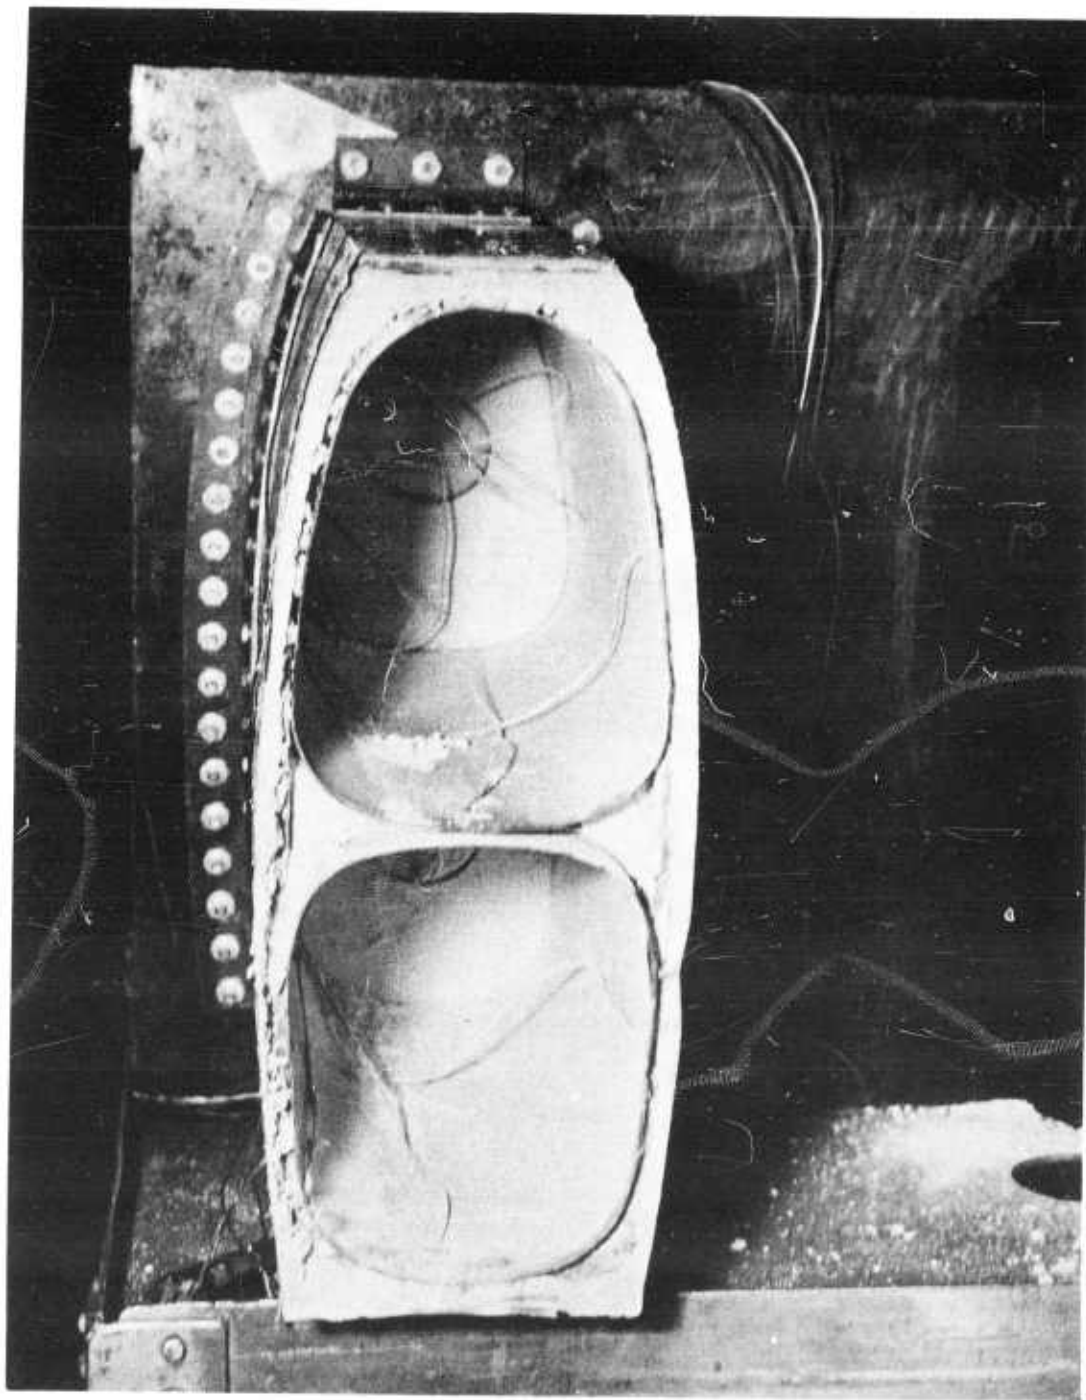
Figure 8-5. View of Duct and Joint Area

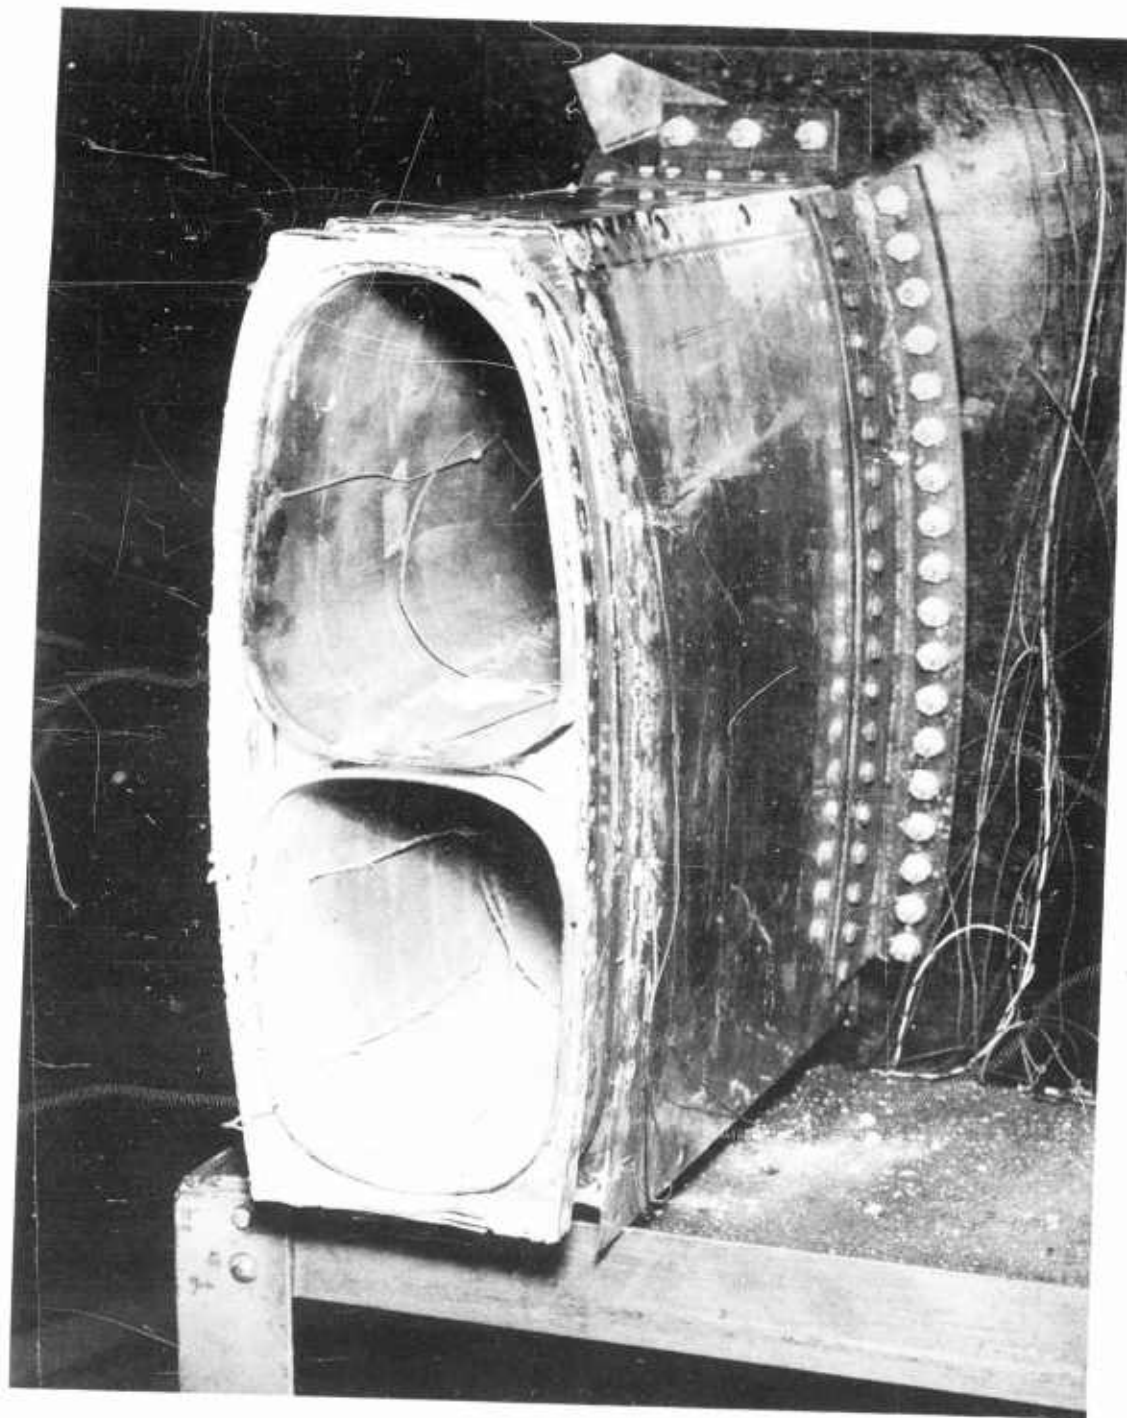
Figure 8-6. View of Duct and Joint Area
